Quarter Chime and Hourly Strike Mechanism 1911 Memorial Turret Clock

Ardingly College

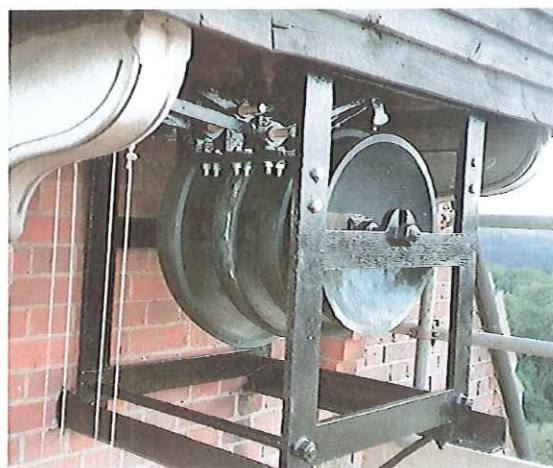
Restored Bells

In the meantime, scaffolding to the roof had allowed for the bells and bell hammers

Strike Autowind to be dis-assembled, restored, and then re-assembled, lubricated and rewired ready for use. The old clock was taken apart and each part cleaned and restored, and then re-assembled on site over many days.

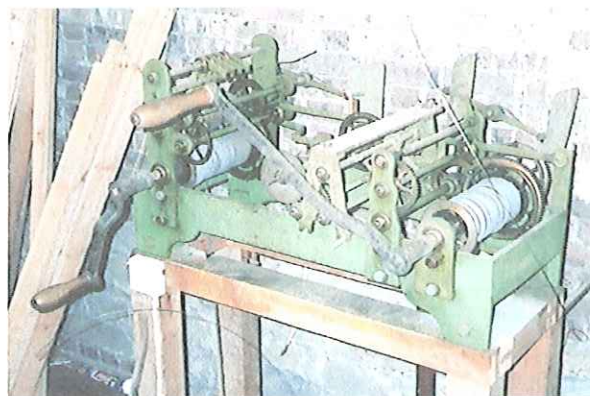
Original Clock Mechanism

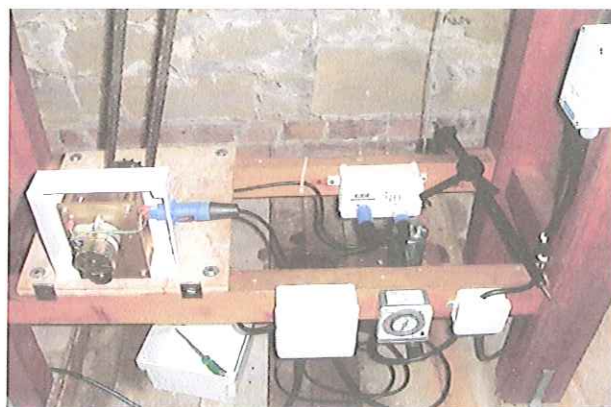
Automation Components
