# St Luke's Church

## The Vulliamy Clock (updated Dec 2016)

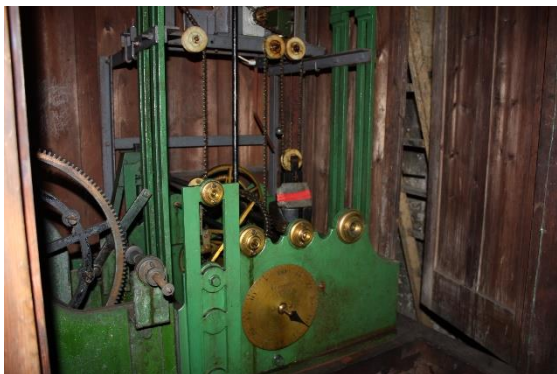
*General view of the clock.*

Other refinements of the St Luke's clock are the pinwheel escapement with Vulliamy's design of self-levelling pallets and a 2-second pendulum with a heavy bob. Both contributed to the clock being capable of an accurate performance. Vulliamy's clocks were substantially more expensive than those of his competitors, but he boldly claimed they would outperform and outlive the cheaper alternatives. While it may not presently be working, the survey of the St Luke's clock in February 2016 revealed a very high quality clock, still in remarkable order.

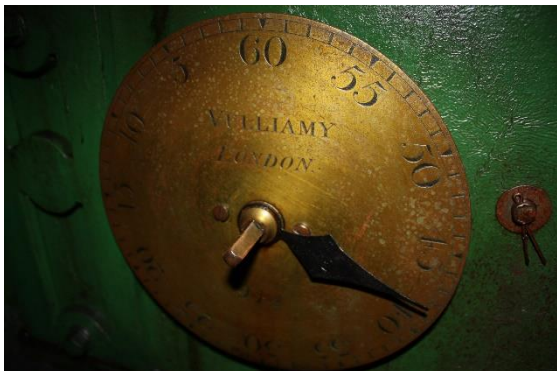
*The setting dial.*

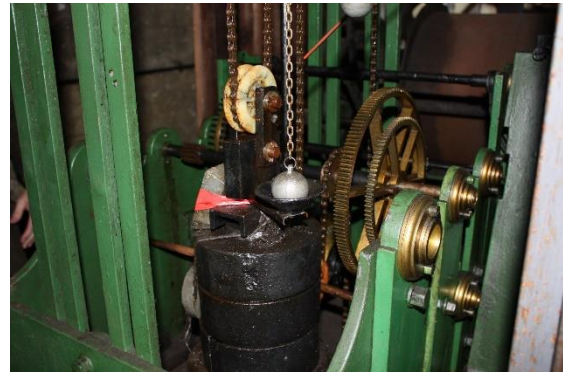
*Earlier auto-winding, showing additional weight being added with sticky tape – not a proper solution.*

Reliance has to be placed on automatic winding mechanisms, infrequent visits, and the chance of stoppage increases as a result, particularly if there are occasional interruptions to the power supply. At a simple level, changing responsibilities for the budget necessary to cover annual maintenance and the spring and autumn time changes can see clocks stop, and then remain stopped.

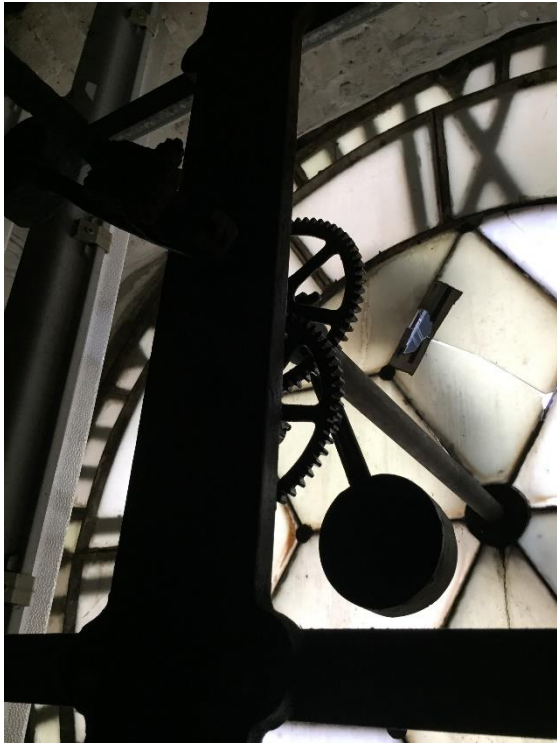
Clock towers are deeply inhospitable environments, cycling in temperature between plus 40 degrees C and falling below zero – with humidity varying from low to 100 per cent over time. The St Luke's tower had its original slate dials replaced in 1928 with the opal glazed versions we see today. These offer a wonderful night-time spectacle, but have serious downsides as well. The original putty fixing of the glass has slowly dried to a cement-like hardness, and the lack of flexibility allows for cracking of the glass, as the cast iron tracery expands and contracts. This leads to moisture ingress, and eventually 'rust-jacking' as the metal

corrodes, and rigid surfaces move against each other. A number of glazed panels failed long ago, and have been replaced in wholly unsuitable plastic, which offers a patchwork impression at night. Many other panels are cracked, and the eventual failure of the glazing is certain.

*Many opal panels are cracked and broken, rust is widespread, and some panels have been replaced with unsuitable acrylic in the wrong colour.*

The job of replacing the glass is by far the largest element in any project. The proper glazing of the dials is vital to the smooth operation and continuing longevity of the clock. The clock is a precision instrument, which requires the best circumstances possible in the clock room in the tower.

The proposal is to arrange the complete overhaul of the clock, the fitting of new automatic winding, the addition of remote monitoring equipment, and the entire reglazing and repair of the four dials. The whole project has a budget of approximately £35,000, not including VAT. This breaks down as follows:

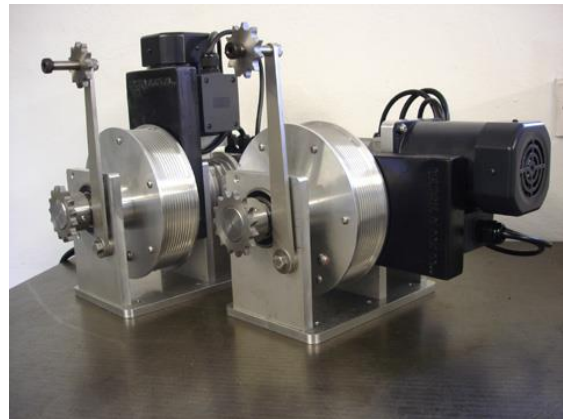
*Robust, modern automatic winding units of the type that will be employed.*

The new auto-winding system will carry a ten-year guarantee, and is to a highly proven design, used nationwide. An added feature is that we expect to provide monitoring of clock performance, visible on the Internet – with the further chance for schools (e.g. Physics students) to lift and lower a fine regulation weight, remotely, and to observe the effect on timekeeping – under supervised and passworded access, of course.

The auto-winding equipment offers the hugely significant benefit that visits to the tower (where access is by vertical steel ladder) are minimised. It will also be important to allow for ongoing annual maintenance, but the contractor that will carry out the main works offers an annual maintenance contract at a cost of just £195 per annum.

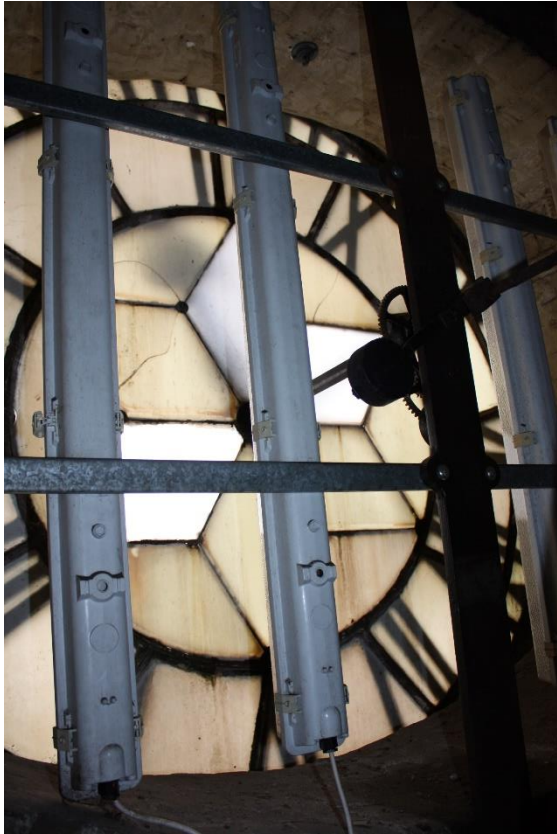
*Another view of a dial, showing poorly replaced opal panels, and extensive corrosion to the iron tracery, and cracking to older glass panels.*
